ATOMIC OXYGEN EFFECTS ON HST-SA1 METALS

A. de Rooij

European Space Research and Technology Centre (ESTEC)
Noordwijk
The Netherlands

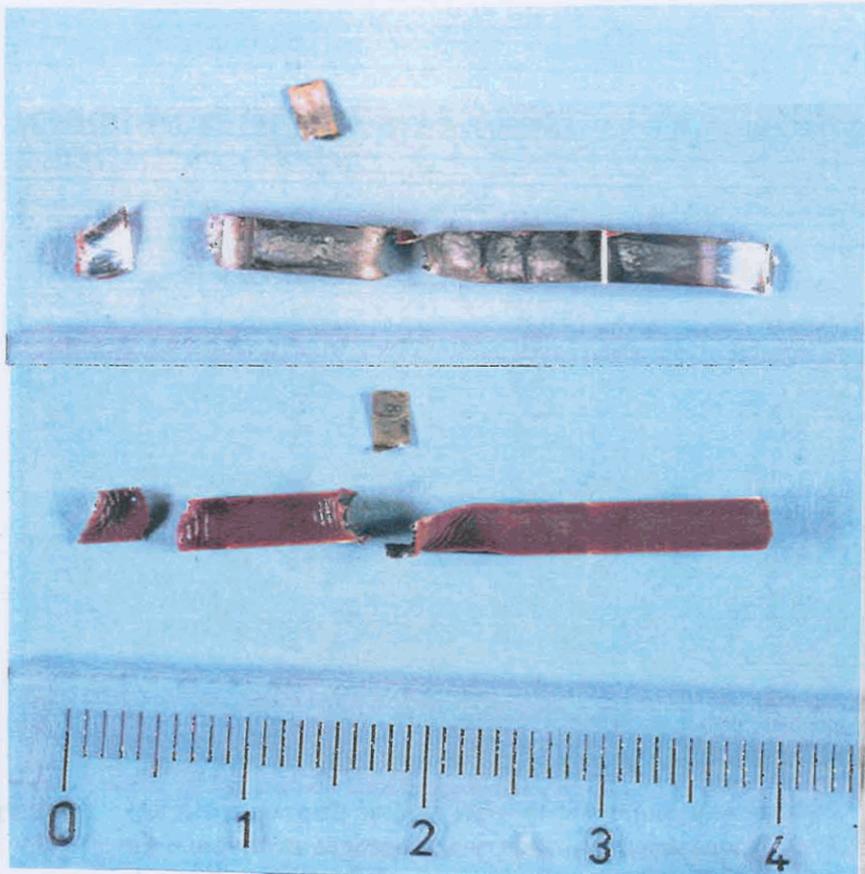
A busbar is examined which was damaged by a micro-meteorite impact. This impact resulted in a breakage of the busbar and opened some interconnector welds. The oxidation of these exposed welds is examined.

Figure 2. *A busbar damaged by a micrometeoroid impact. Due to this impact some connector tabs detached from their weld on the busbar.*
The bottom picture shows the RTV side of the busbar, while the top picture shows the silver side of the busbar.
Magn. X2.3

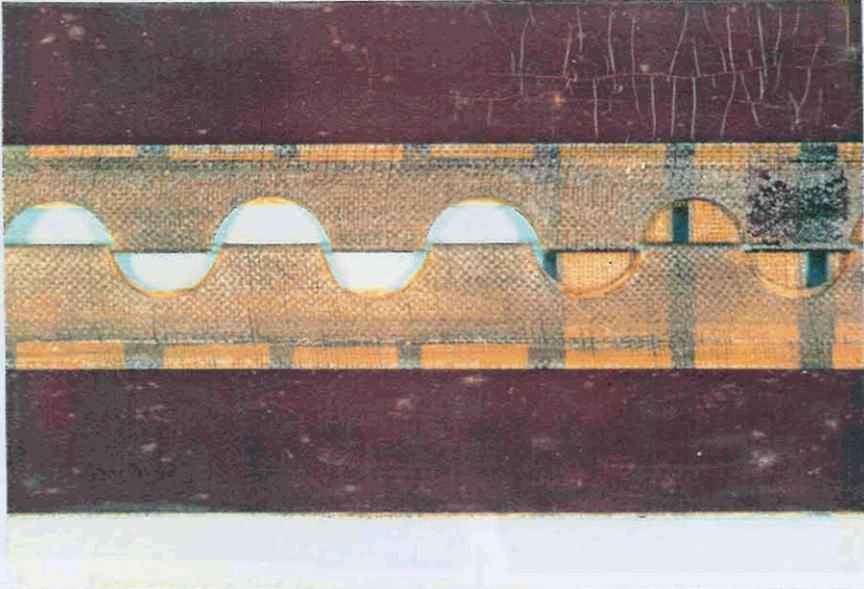
The effect of atomic oxygen exposure on the incoloy hinge rod was absent or at least impossible to measure. The exposed areas are very small and were during their life always in close contact with the solar array blanket. This blanket was protected at both sides with silicone DC93500 and this silicone was always detected on the exposed part of the incoloy hinge rod. The minor discolouration could always be contributed to the presence of this silicone layer.

Figure 3. *Detail of hinge rod/bridge piece between SPA D and SPA E. The exposed parts of the hinge rod is just visible between the blanket folds.*

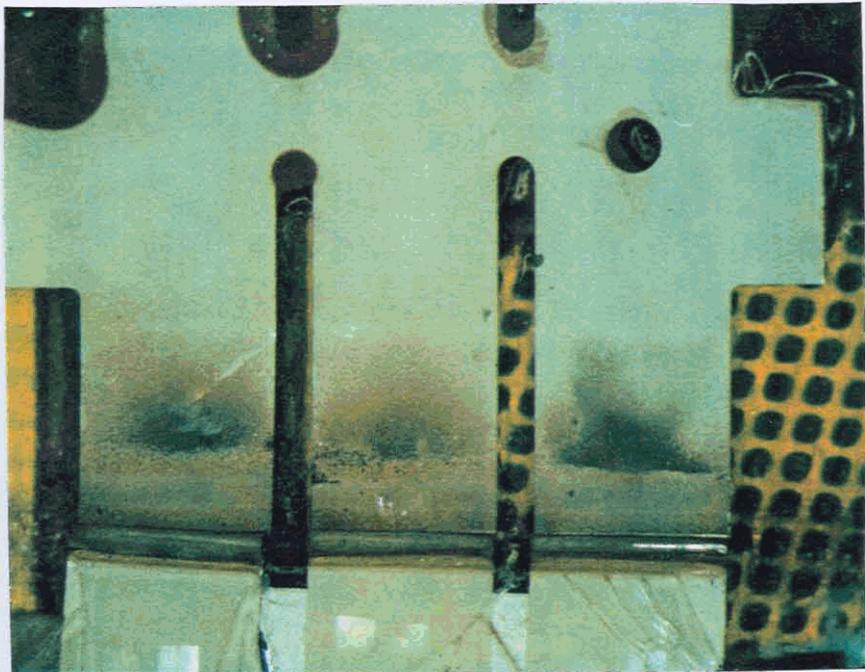
Atomic oxygen not only attacks surfaces which are exposed directly to the flux, also surfaces not directly exposed, but in one way or another accessible to the atoms can be oxidised. Figure 4 shows an example of this. After removal of the two cells at both sides of this interconnector the attack on the silver surface, previously under the cell, is visible as a dark layer. The same phenomenon occurs at the rear side of the interconnector especially at the location of the stress relief loop. The amount of attack at these sides accounts for approx. 25-50% of the loss of silver thickness. All investigated interconnectors show this effect.

Figure 4. *The two solar cells at both sides of this interconnector are removed to expose the complete interconnector. It shows the attack of the atomic oxygen on the silver (the blackened surface towards to p-weld) under the removed cell.*

Magn. X12

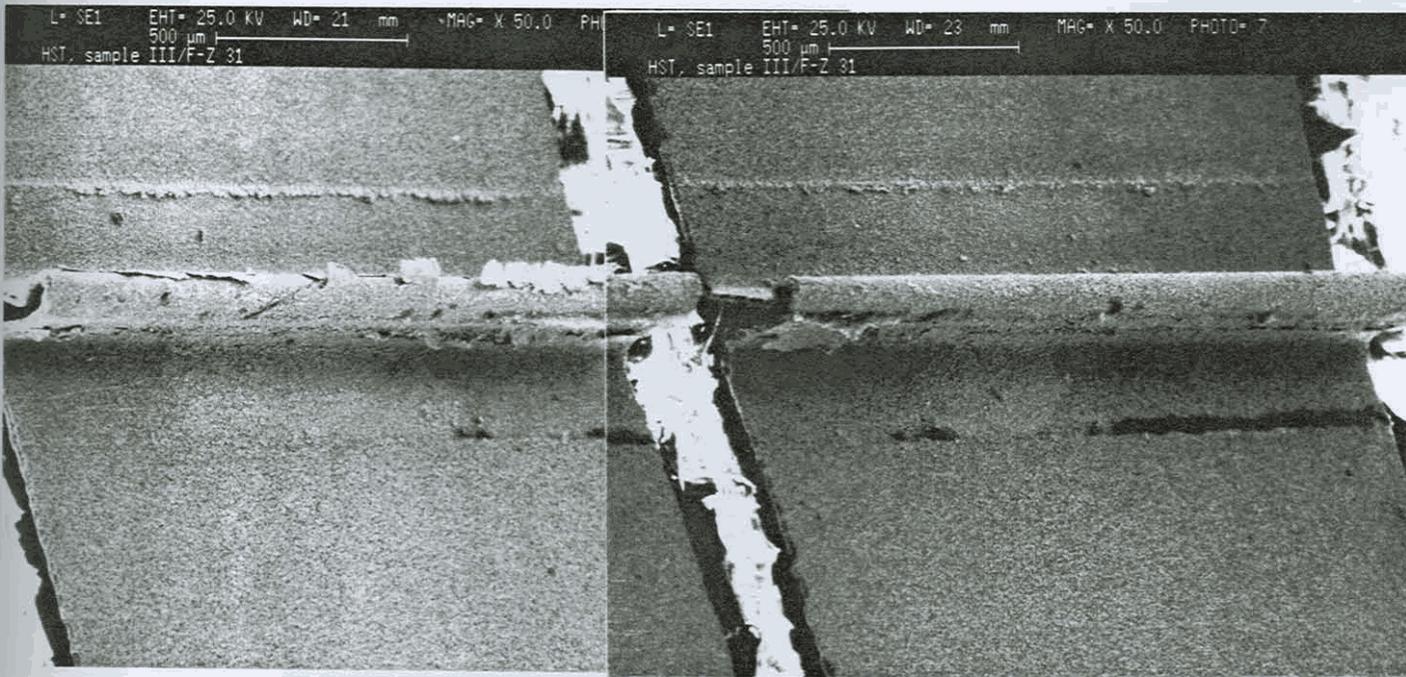
The total amount of attack on the stress relief loops varies. In some occasions the oxide remained completely on the surface and minor attack is observed. In other occasions total flaking occurred and the complete silver layer is removed.. No particular reason could be given for this phenomenon. In

some instances these two situations were found only half a millimeter apart as is shown in figure 5. Here we observe two stress relief loops from one tapping bar located between two cells. The right loop shows an attacked surface, but the oxide layer remained in place and protected the underlying material. The left picture shows just the opposite situation. The silver layer is totally destroyed and large amount of flaking is present. These two stress relief loops experienced exactly the same environment, were manufactured in the same operation and are made of the same material. The difference in oxidation behaviour is probably due to minor differences in stress seen during thermal cycling or small amounts of contamination from the silicone adhesive used for bonding the solar cell onto the substrate or the coverglass to the solar cell.

Figure 5. *Two stress relief loops on the same tapping bar (the two cells at both sides of these loops were removed). The left stress relief loop shows heavy flaking and in some places the silver is totally removed. The right one shows no flaking but an intact oxidised surface. The complete silver thickness (partially changed to oxide) is still present. Magn. X50*

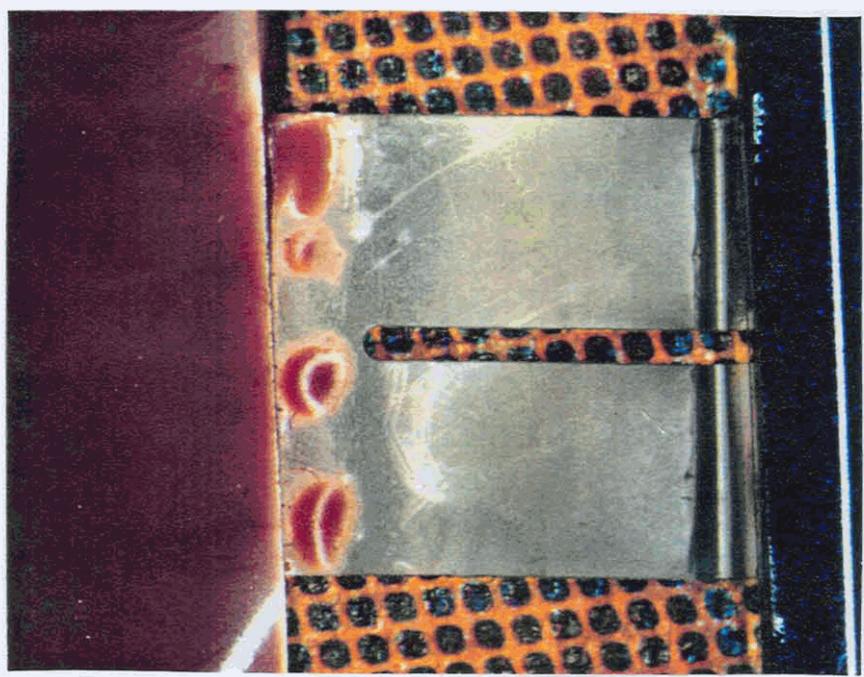
The same situation can occur on flat surfaces. Flat surfaces usually do not show excessive flaking of the oxide layer. The stresses in the material is lower than those in the stress relief loops. The oxide layer on flat surfaces do crack but tend to remain on the surface. The flat surface seen in figure 6 is an example of this. That this is not always the case is illustrated in figure 7. Large flakes and oxidation under these flakes are present. A few tapping bars showed this behaviour. No particular location on the solar array assembly could be attributed to the observed differences.

Figure 6. *Front side of tapping bar between solar cell and stiffener. The silver surface is slightly oxidised and no flaking is present. Magn. X12*

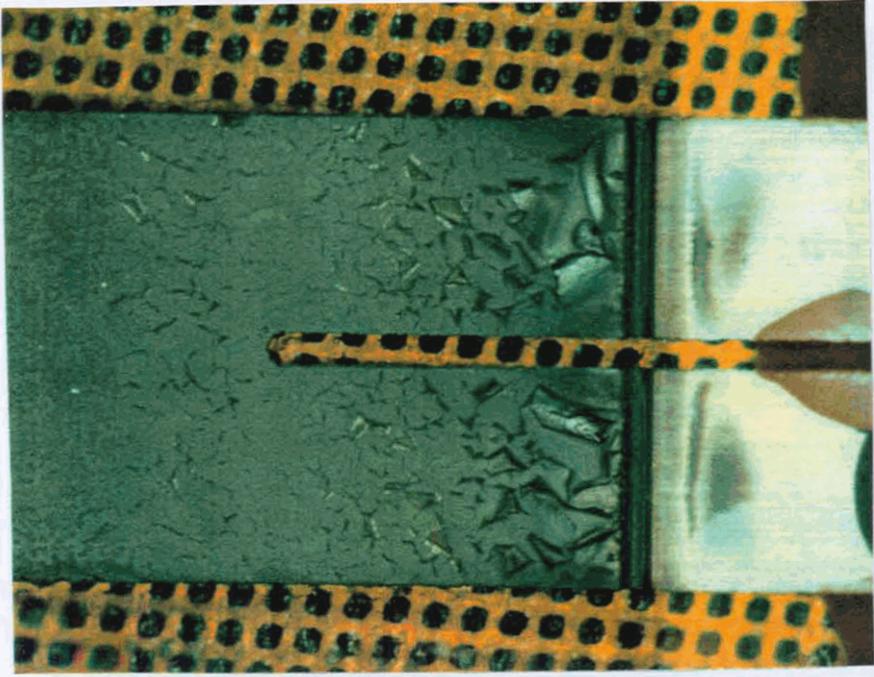
Figure 7. *Front side of tapping bar showing heavy oxidation with large flakes of silveroxide. The heaviest flaking has occurred close to the stress relief loop, further away the flakes are transformed to surface cracks.
Magn. X12*

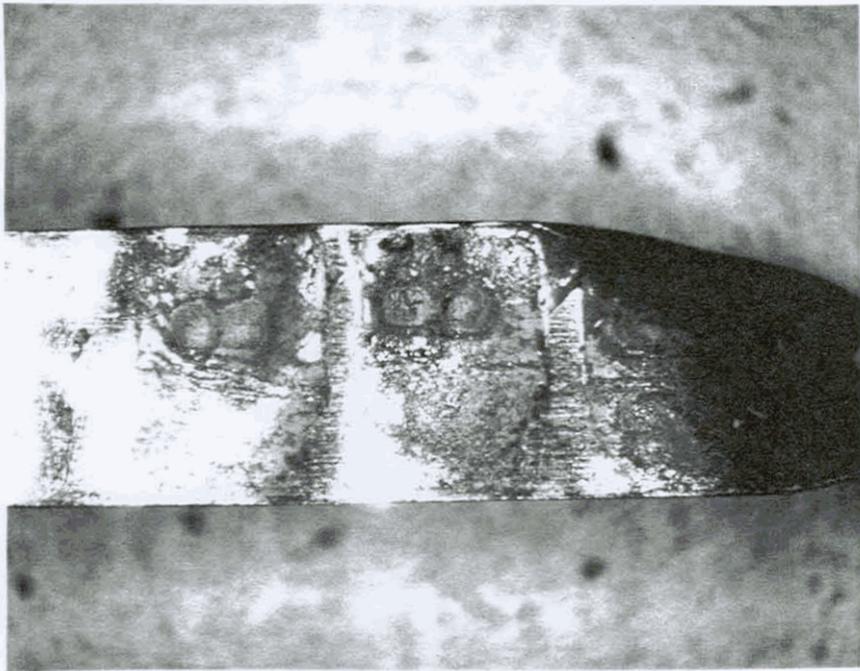
The examination of a totally clean silver surface exposed to atomic oxygen was possible when a micrometeoroid had impacted and totally penetrated through a busbar. The busbar was locally destroyed and an interconnector tab came loose from the busbar, thus exposing the previous weld area on the rear side of the busbar to atomic oxygen. The difference between a clean silver surface and a contaminated silver surface both now exposed to atomic oxygen is now clearly visible. Due to the large amount of silicone used, the area in the vicinity of the weld is covered with a contamination layer. After the weld separation this contaminated surface as well as the fresh surface were exposed at the same time and seeing the flux. The result is illustrated in figure 8. The fresh silver surface is totally oxidised and the oxide layer is raised out of the plane of the busbar, while the surrounding surface shows only traces of oxide.

Figure 8. *Rear side of busbar after micrometeorite had impacted and lifted the busbar and detached a weld tab. Fresh silver surface from the previous weld is completely oxidised, while the surrounding area shows much less oxidation due to the presence of a silicone contaminant on the surface.
Magn. X12*

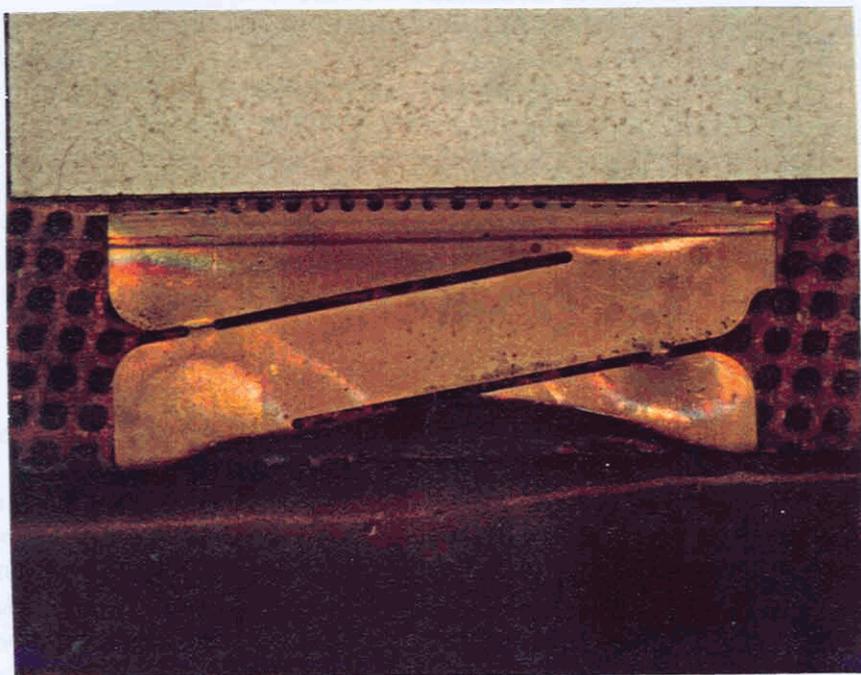
The change in gold surfaces after atomic oxygen exposure is in general minor. The changes which are visible on the gold plated silver interconnector can in general be contributed to silveroxide on the gold surface. In some cases the silveroxide can be traced back to small pinholes in the gold surface, through which the silver is oxidised. In other cases no defects under the oxides are detected. Some silver oxidation on gold surfaces can be seen in figure 9. Not all dark discolourations are characteristic of silveroxide., the majority of the discolouration consists of oxidised silicone contaminants. Darkening close to edges is usually associated with silveroxide.

Figure 9. Gold plated silver interconnects from diode. The gold surface shows some pit-like attack on the edges. The dots are associated with silveroxide from the bulk of the connector. Other stains originate from the presence of silicone on the surface. Magn. x12
