# SPACE EXPOSURE OF HST-SA1 TAGBOARDS

### A. de Rooij

### European Space and Research and Technology Centre (ESTEC) Noordwijk

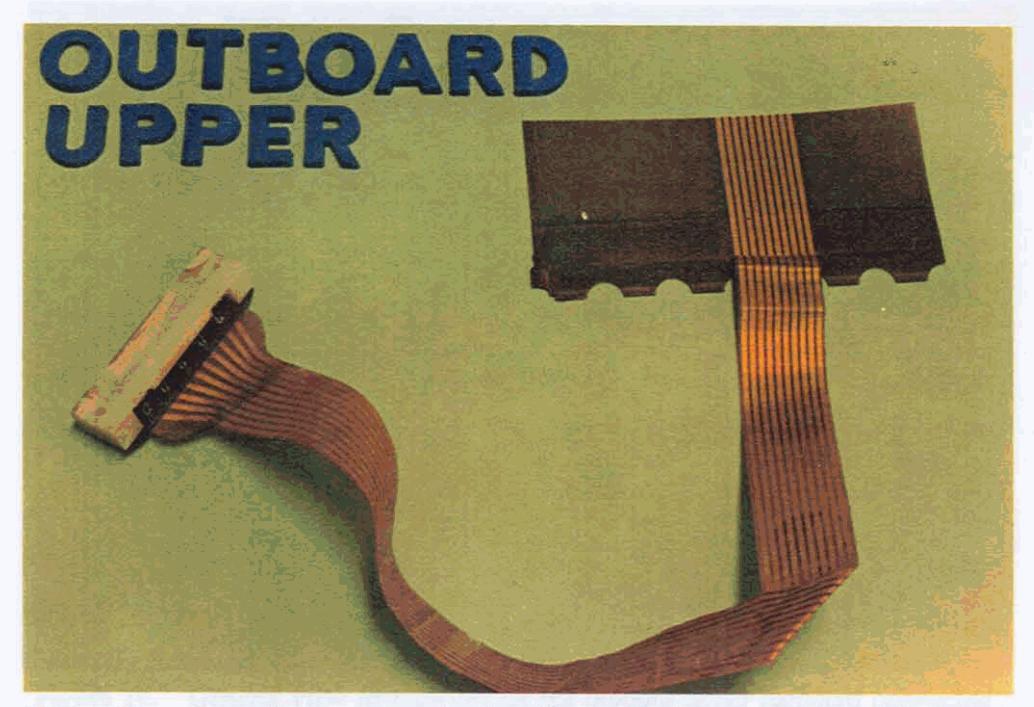
Figure 1a. General view as received on the outboard upper tagboard connected to the flexible harness. Magn. x0.5

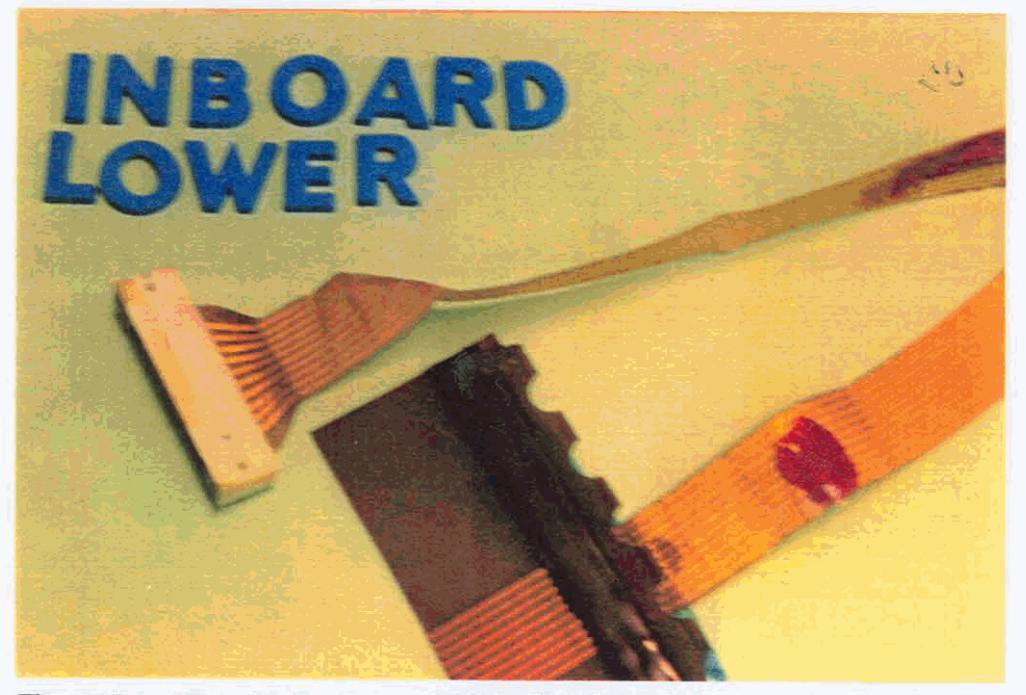
Figure 1b. General view as received on the inboard lower tagboard connected to the flexible harness. Magn. x0.5

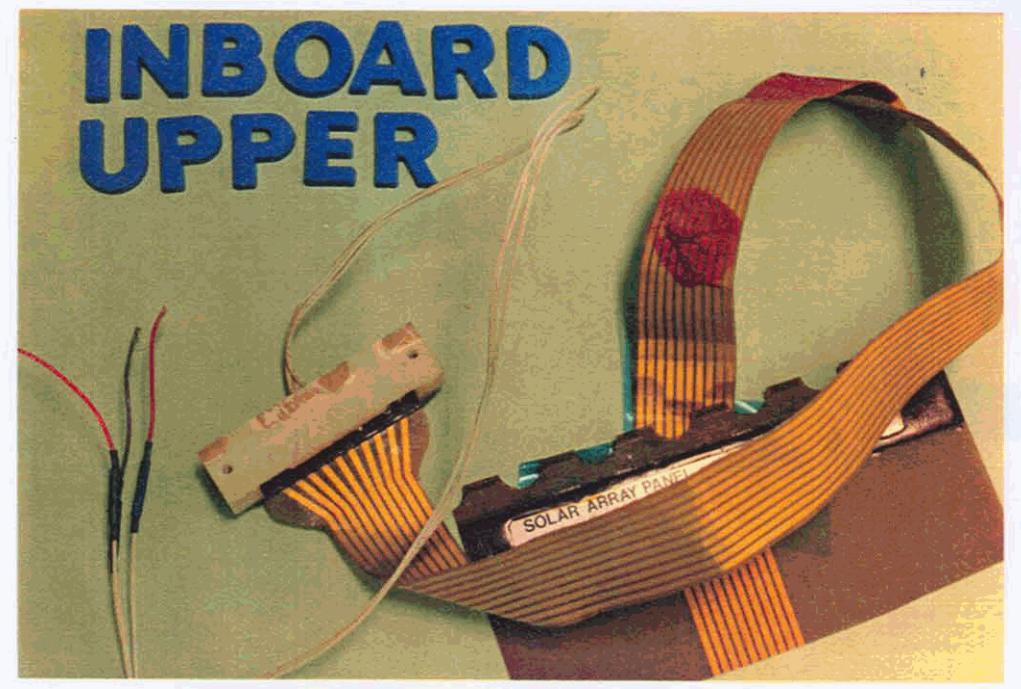
Figure 1c. General view as received on the inboard upper tagboard connected to the flexible harness. Magn. x0.5

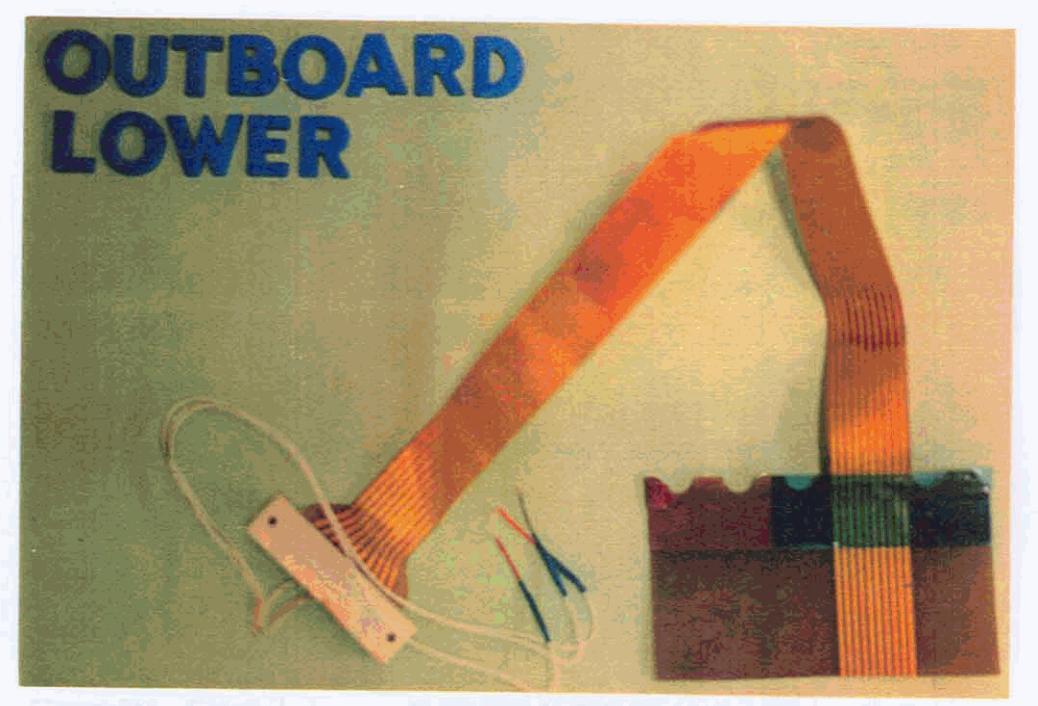
Figure 1d. General view as received on the outboard lower tagboard connected to the flexible harness. Magn. x0.5

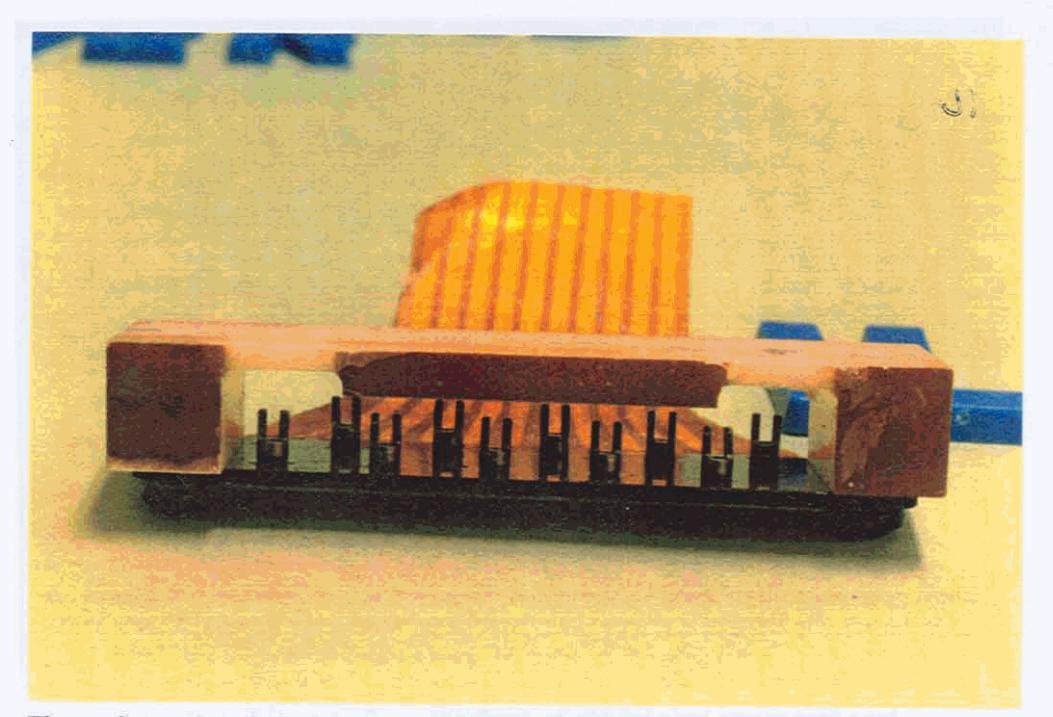
The visual inspection of the tagboards shows some common features on all boards. The delrin tagboard holders and the conductor leads show dark brown stains (figure 2a-d). These dark brown stains will not be further investigated in this report but will be addressed in further investigations.

Figure 2a. Detailed view from the front of the inboard lower tagboard, showing that no conductor wires are connected to the terminal pins. Notice the brown stain at the front. Magn. x1.75

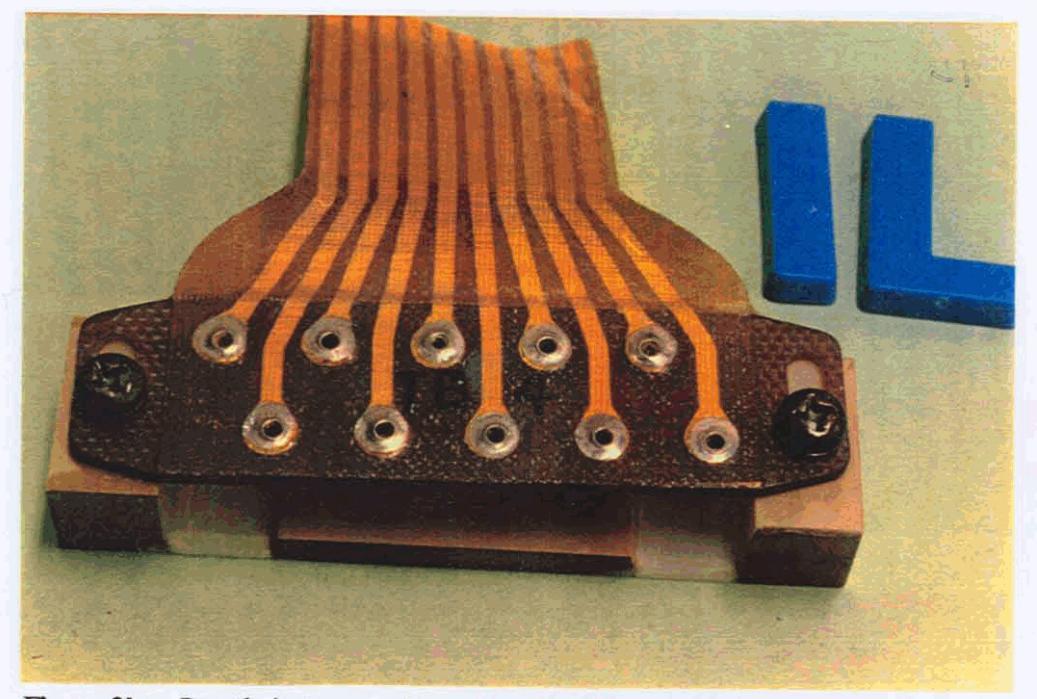
Figure 2b. Detailed view on the tagboard of the inside lower connection. None of the terminal holes are filled with solder alloy. magn. x1.75

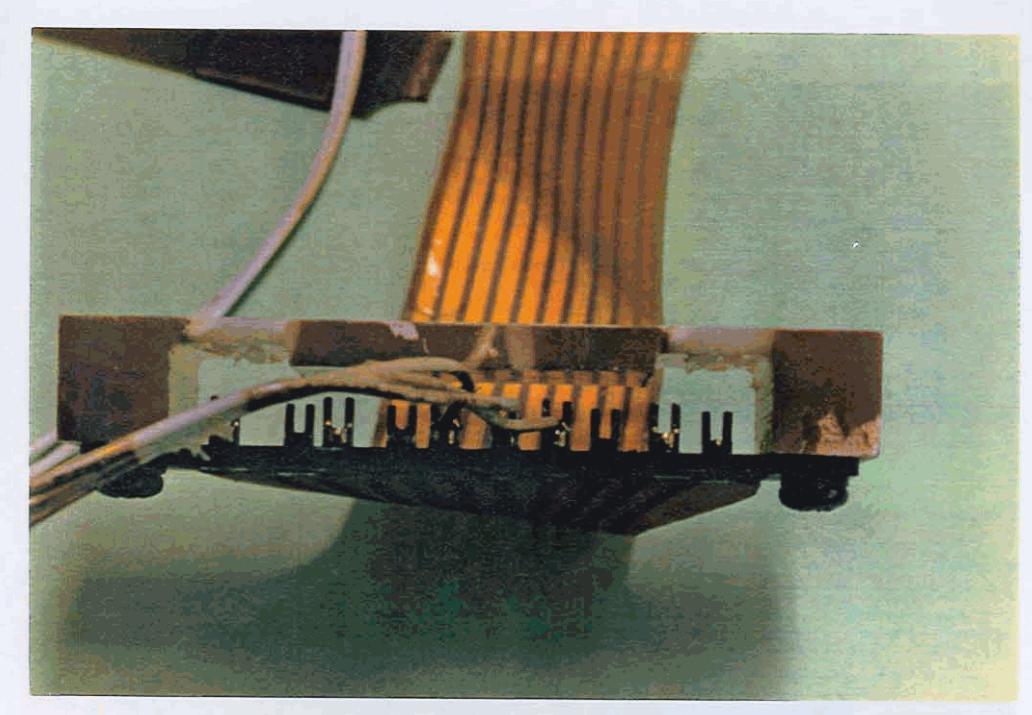
Figure 2c. Detailed view from the front of the inboard upper tagboard, showing that three conductor wires are connected to the terminal pins. Notice the brown stain at the front. Magn. x1.75

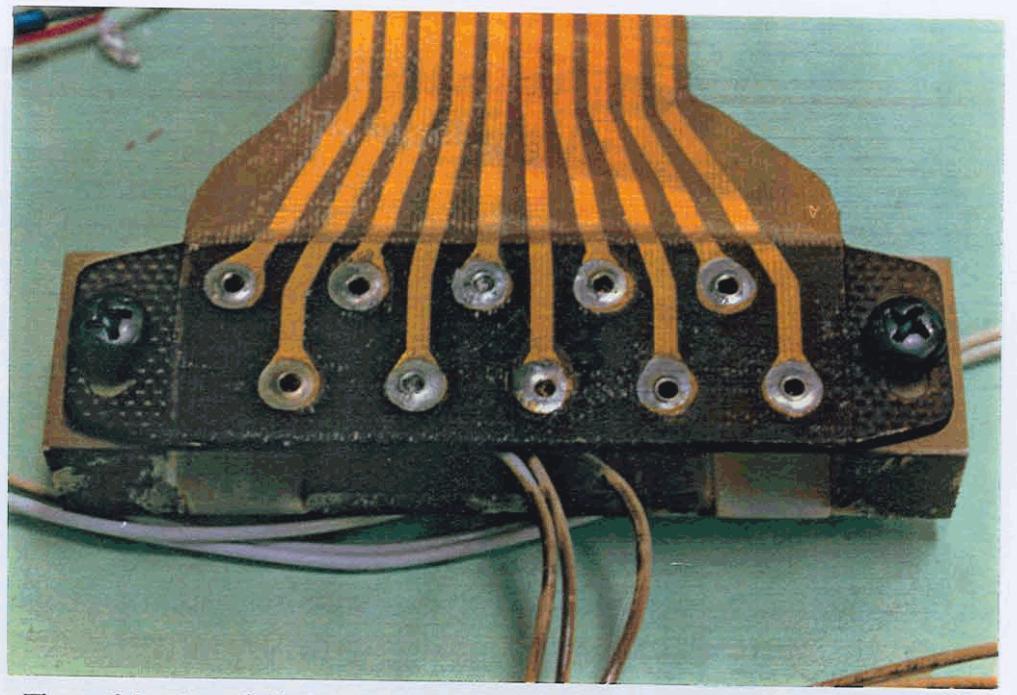
Figure 2d. Detailed view on the tagboard of the outside lower connection. Three of the terminal holes are filled with solder alloy because of the conductor lead soldering. magn. x1.75

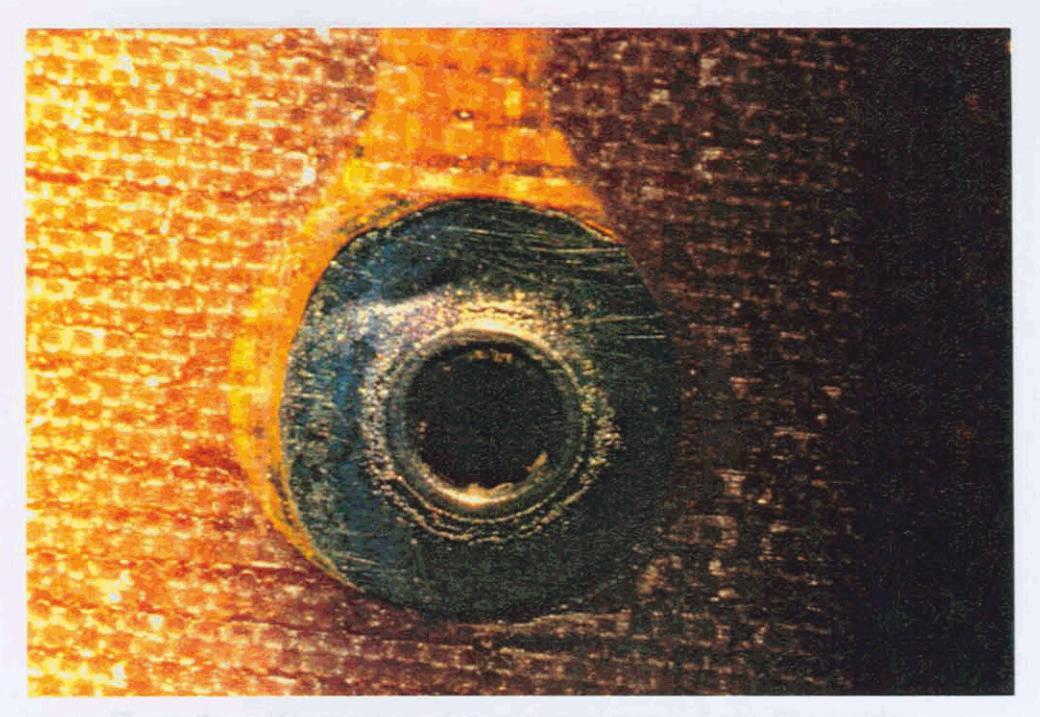
The six bifurcated terminals containing a conductor lead more or less cracking of the solder fillet. An example of a  $360^{\circ}$  crack in a solder fillet can be found in figure 3a. An example of the orange peel effect on a solder fillet is found in figure 3b.

Figure 3a. Detailed view on a solder fillet from a connected terminal pin from on the outside lower tagboard, showing the circular cracking in the solder fillet. Magn. x12

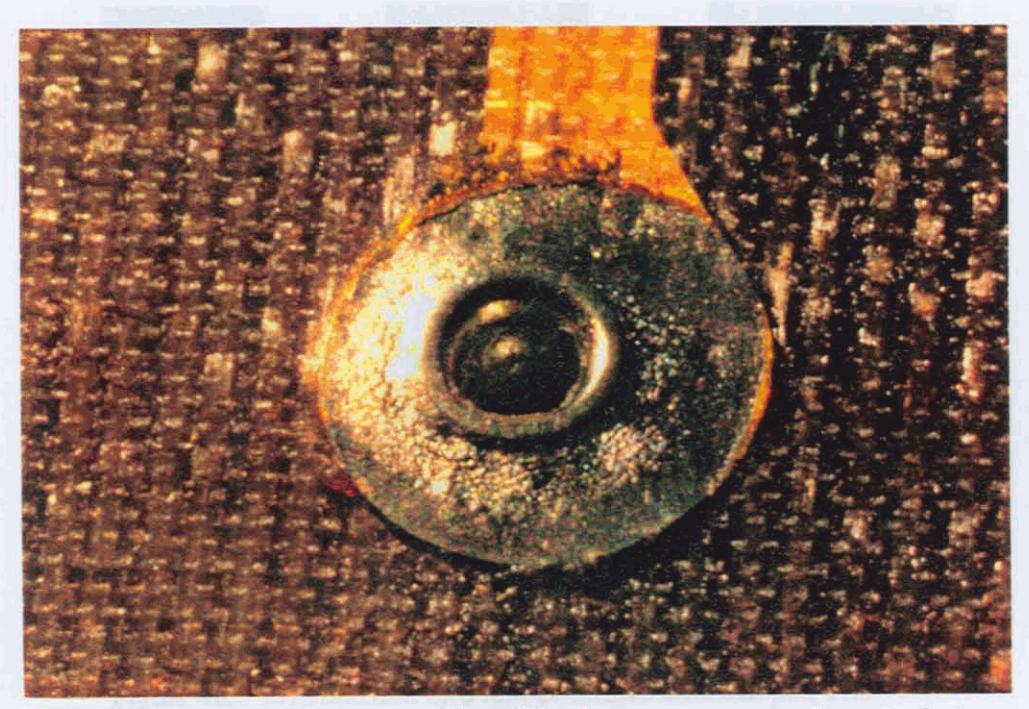
Figure 3b. Detailed view on a solder fillet from a un-connected terminal pin from on the inside lower tagboard, showing the orange peel effect on the solder fillet. Magn. x12

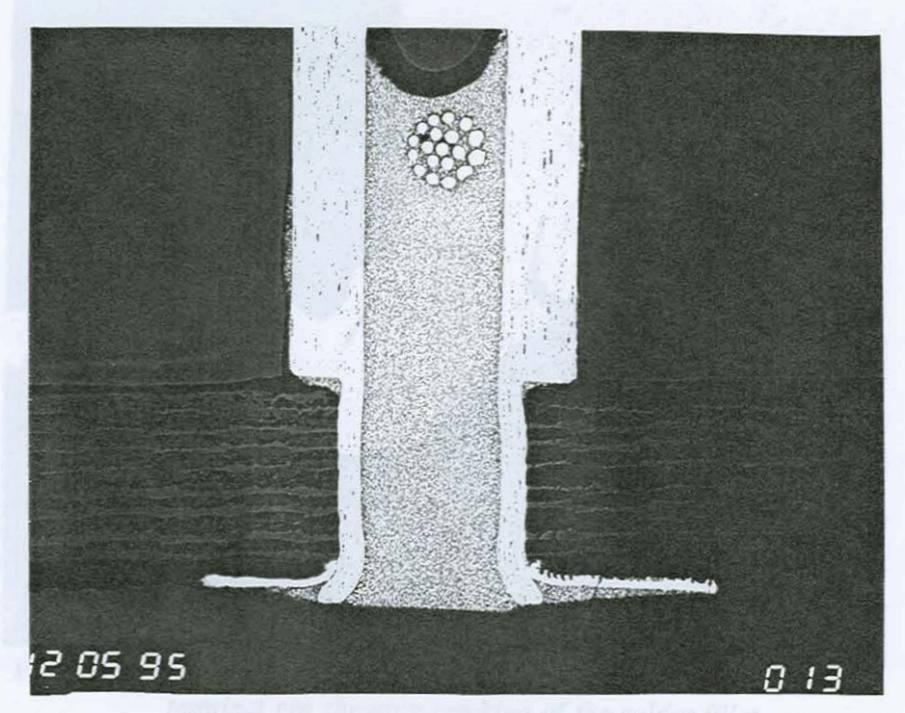
Microsectioning reveals if the cracks found during visual inspection are real solderjoint failures. Microsections of a connected terminal pin and an unconnected one are shown in figures 4a-b. The swaged ends are clearly visible and the solder fillet connects the pad to the swaged end of the terminal. In the case of a connected terminal pin the complete bifurcated terminal is filled with solder alloy. Detailed view of the solder fillet area are given in figure 5a-b. These photographs are not from the terminal from figure 4 but from identical ones at another position.

Figure 4a. Microsection of a connected terminal pin. The inside of the terminal pin is filled with solder alloy. The swaged end of the terminal pin is soldered to the ad on the board. Magn. x16

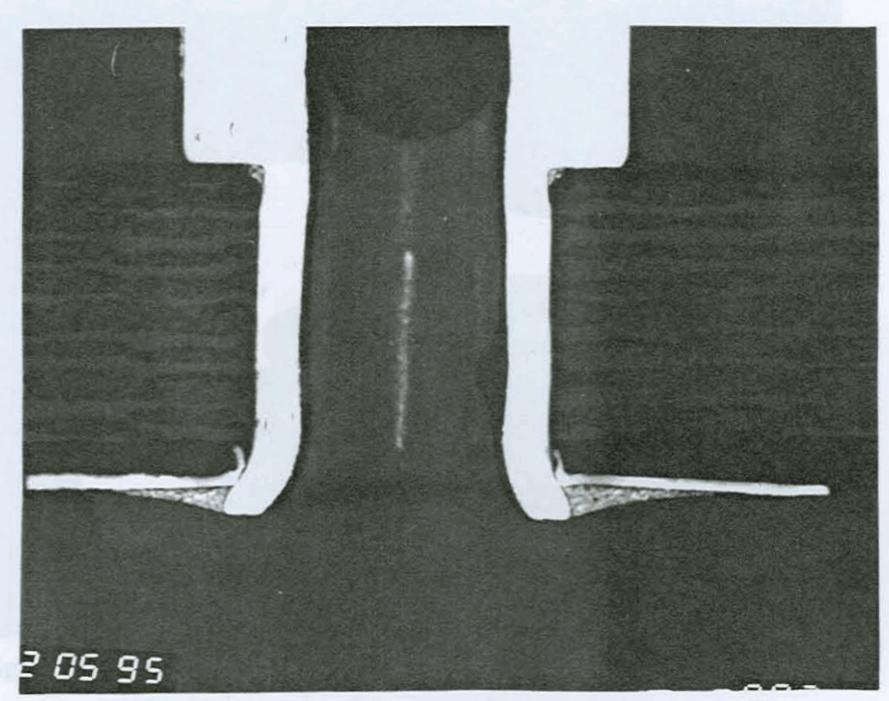
Figure 4b. Microsection of a non-connected terminal pin. The inside of the terminal pin is not filled with solder alloy. The swaged end of the terminal pin is soldered to the pad on the board. Magn. x32

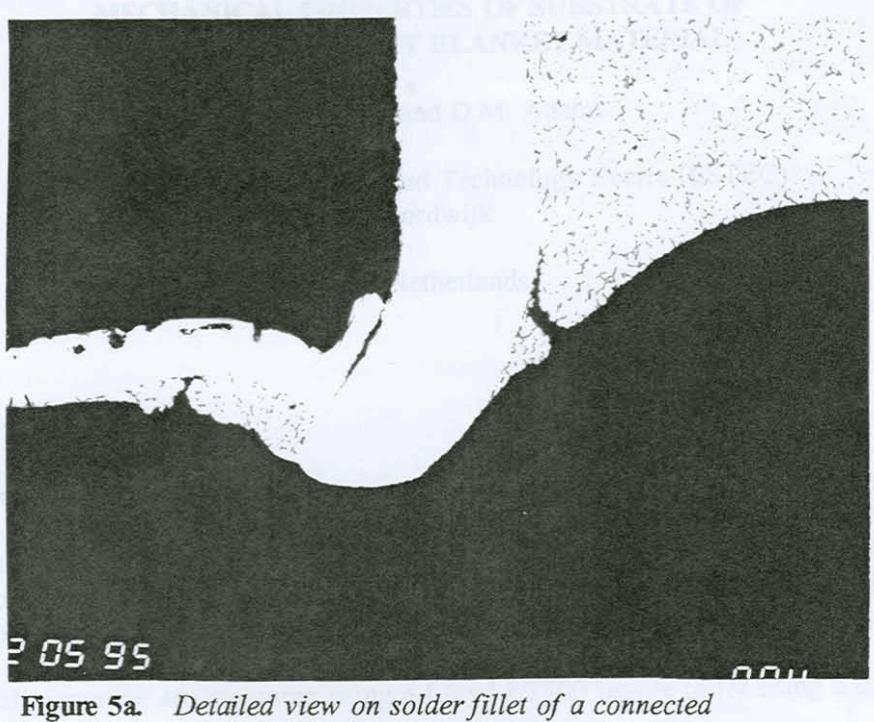
The detailed view of the solder fillet of the connected terminal pin shows the locations of the 360<sup>o</sup> cracks in the solder fillet (figure 5a). However, none of the connected joints failed after the 21000 thermal cycles. An adequate electrical path is still present between the conductor lead to the terminal to the solder pad. The cracks do not penetrated into the joint. None of these type of defects are seen on the non-connected terminals. The surface of the solder fillets are roughened (figure 5b), but no cracks are visible.

5a. Detailed view on solder fillet of a connected terminal pin showing cracking of the solder fillet and cracking in the solder inside the terminal pin area. Magn. x100

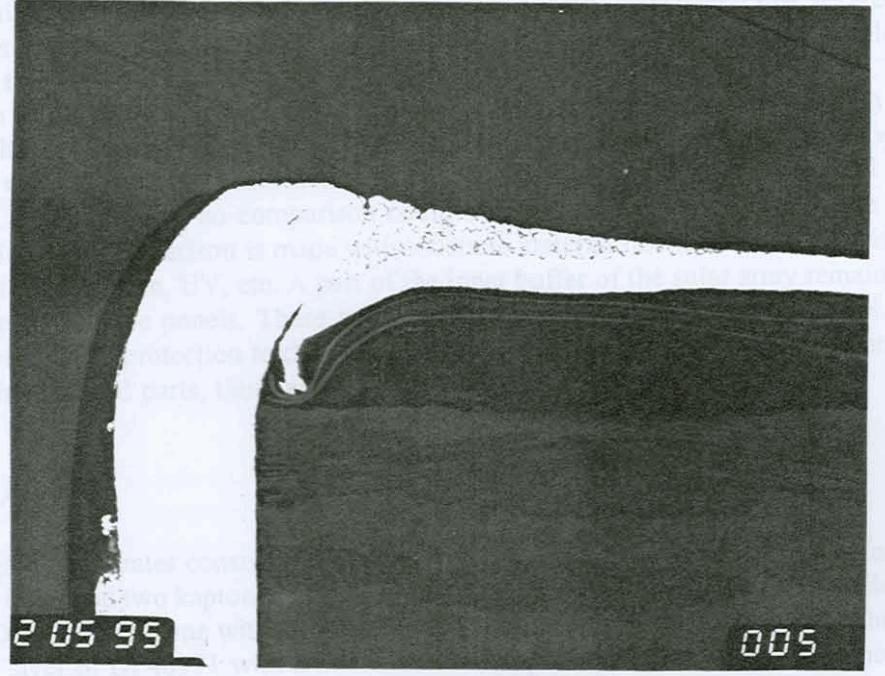
Figure 5b. Detailed view on solder fillet of a non-connected terminal pin showing no cracking in the solder fillet. Magn. x100
