THE DEGRADATION OF METAL SURFACES BY ATOMIC OXYGEN

A de Rooy

ESA/ESTEC Materials Section, Noordwijk, The Netherlands

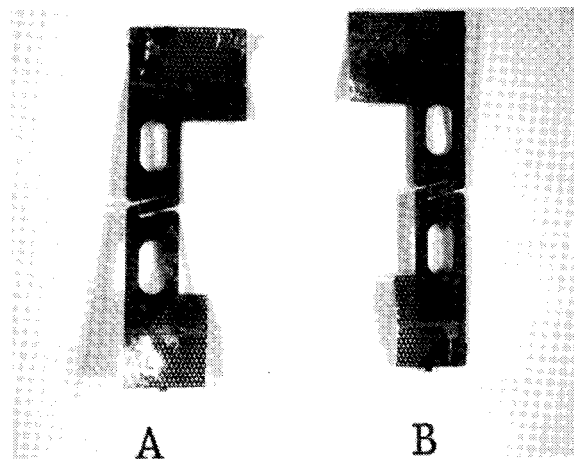
Both front and back faces of the samples with exposed silver show brown-black stains except where they had been masked off by adhesive tape. On closer examina-

Figure 1. Macroview on the tested silver interconnectors. Note the discolouration on the surface. Magn. X 2.1.

tion the stains appear to be a thin scale which easily flakes away from the surface. (Fig. 1).

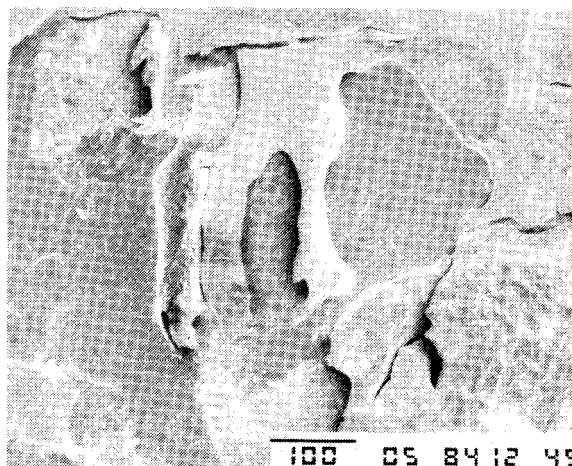
In all SEM pictures the flakey nature of the stains on the exposed silver is apparent and the underlying areas expo- sed by the flakes are visible. The thin flakes appears to be curling up and spalling away (fig. 2a). X-ray analysis indicates silver and chlorine associated with the stain. However, analyses of further stained areas reveal that the chlorine level associated with the stain is very variable and sometimes even nil. Wavelength dispersive X-ray analysis of the stained areas shows the presence of silver with low levels of oxygen and carbon with variable levels of chlorine.

This surface shows flakes curling up to expose underlying areas of bare silver.

Figure 2a. Exposed silver surface. SEM micrograph showing flaking off of the silver-oxide layer. Notice a secondary flake (arrow) on an already attacked surface. Magn. X 150.

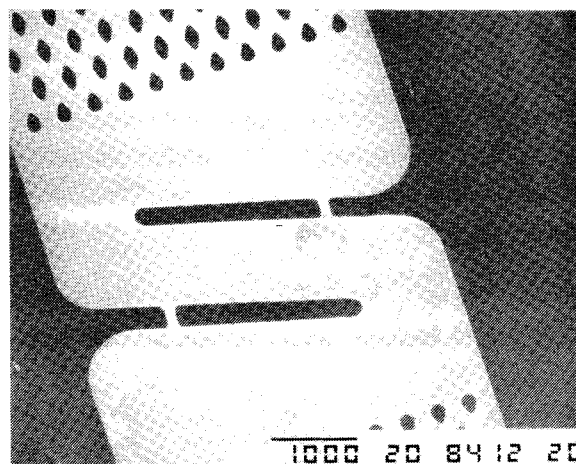
Apart from the black shiny appearance of sample 3, the gold on the partly coated samples appears to be mainly unaffected (fig. 2b). The influence of the atomic oxygen on gold is evidenced by the dif- ference in surface morphology of the 50 nm gold coating under the adhesive tape and the part exposed LEO. On the former region the black shiny appearance is ab- sent. X-ray analysis records the presen- ce of silver and sulphur on the 50 nm gold coating. X-ray analysis in the thicker 500 nm gold coatings reveal only sulphur being present.

Figure 2b. Exposed partly coated silver surface (50 nm gold at arrow). SEM picture showing apparently no attack of the gold. Visual inspection revealed some discolouration of the gold. Magn. X 15.

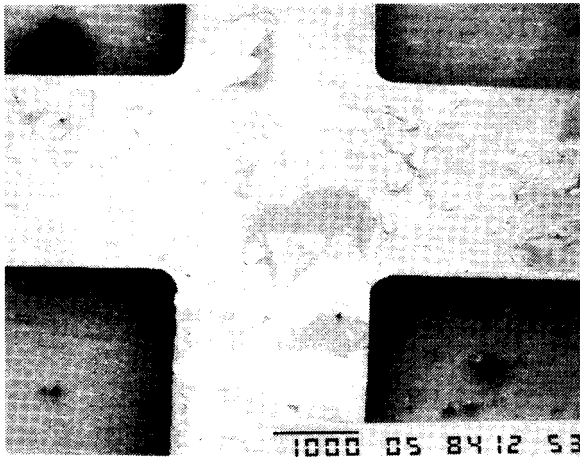
Figure 2e. Exposed silver coated molybdenum interconnector. SEM micrograph showing silver oxides flaking off of the surface. Molybdenum is not yet exposed. Magn. X 15.

Another widely used interconnector material in space technology is 5 um silver coated molybdenum After exposure to atomic oxygen the silver is flaking away as expected from the surface exposing underlying areas which have an etched appearance. This specimen was silver coated over the complete surface and consequently no bare molybdenum was exposed to LEO (fig. 2e). X-ray analysis reveals the presence of silver and traces of molybdenum and platinum

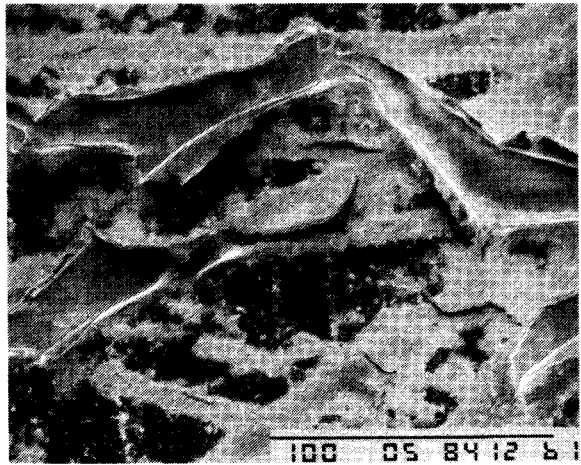
The apparent atomic oxygen affect on the two silicone coatings differ consi- derable between each other. On the sur- face of the specimen coated with DC6- 1104 (fig. 2c) no noticable features are present, except for some charging ef- fects due to the SEM environment, this is in contrast to the second silicone coating DC1200 "residue" (fig. 2d) where shiny and blackened areas are present.

Figure 2d. Exposed silver foil coated with silicone DC1200 "residue". The SEM micrograph reveals silver-oxide flaking off of the surface, indicating that this coating is not protective. Magn. X 50.

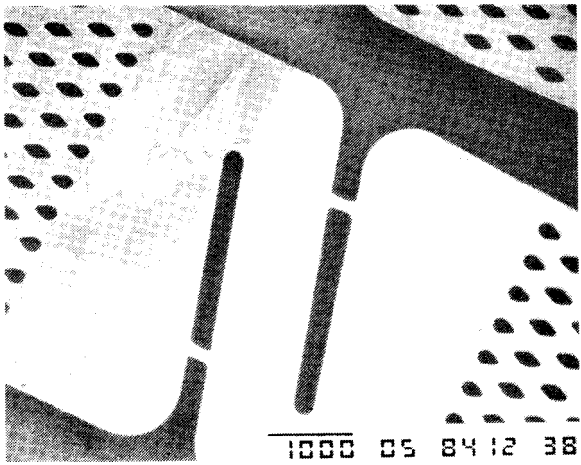
Figure 2f. Exposed partly coated silver interconnector (coating: 50 nm Al). No visible signs of attack are found on the aluminium surface. Magn. X 15.

One of the well known properties of aluminium is its very stable oxide in oxidising media. The two aluminium samples (one bare aluminium foil and one 50 nm aluminium coating on silver) illustrate this again. On the level of investigation in the SEM no affect of the atomic oxygen environment is encountered on these surfaces (fig. 2f).

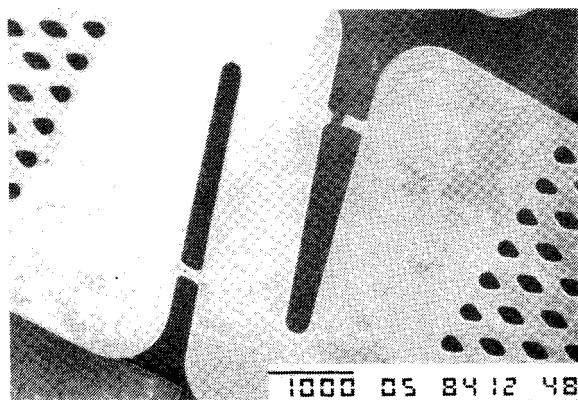
Of the metals of the platinum group, palladium has promising properties in relation to atomic oxygen attack. No signs of flaking of the palladium are observed on both palladium coated silver interconnectors (fig. 2g).

Figure 2g. Exposed partly coated silver interconnecter. (coating: 50 nm Pd). The palladium surface is not attack, but signs of non-plating are visible. Magn. X 15.

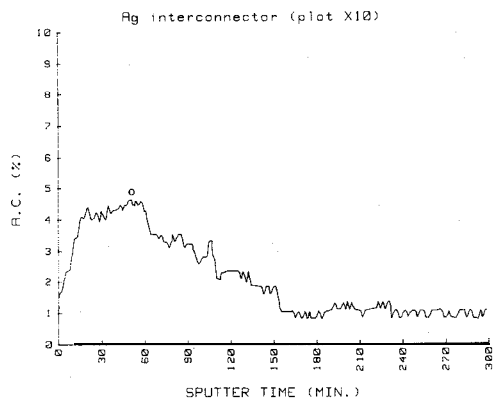
The main contaminants found on the silver surfaces after exposure are carbon and chlorine with smaller amounts of sulphur, oxygen and sodium Depth profiling into the atomic oxygen attacked silver surface (fig. 3a) indicate that the sulphur and chlorine layers are very thin, but that there is a carbonaceous layer of approximately 50-100 nm thick followed by a layer which is essentially silver and oxygen of about 2 to 3 um in thickness. This layer contains about 5% oxygen. The thickness of this layer depends on the positions of the specimens relative to the velocity vector of the spacecraft. Samples perpendicular to this vector exhibit an oxide layer in the low range while samples tested 45⁰ to this vector have an oxide layer in the high range of the observed spread in layer thickness. Depth profiling into the reverse face of the interconnectors shows a similar film to that found on the front face with an oxide layer of about 1.5 to 2 pm thick.

Figure 3a. **Auger depth profile of oxidised silver surface. Apart from the contaminants on the surface, a silver oxide layer (oxygen content 5%) is found to a depth of approx. 1.5 μm.**

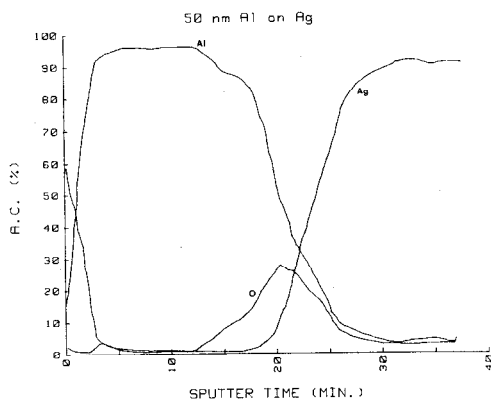
Figure 3d. **Auger depth profile of exposed 50 nm Al on Ag. A small amount of Ag is found on top of the Al surface. This surface shows probably normal Al_2O_3.**

The survey scans of both aluminium interconnectors are very identical. Apart from Al and O, Si is the only contaminant present. Depth profiling suggests a mixed layer of oxidised Si and Al of 4-5 nm thick, followed by an oxidised aluminium layer of 7-8 nm Approaching the Al/Ag interface on the aluminium coated silver interconnector the oxygen signal rises again owing to the presence of an interfacial contaminating oxide layer, probably due to gettering of oxygen in the vacuum system during evaporation of the aluminium on the silver surface (fig. 3d).

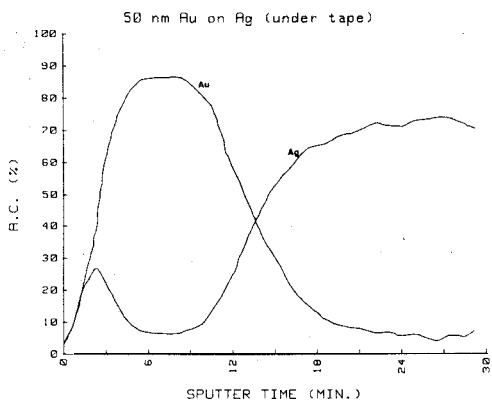
Figure 3c. **Aguer depth profile of unexposed 50 nm Au on Ag (same interconnector as in Fig. 2b) still a small amount of Ag is found on the Au surface.**

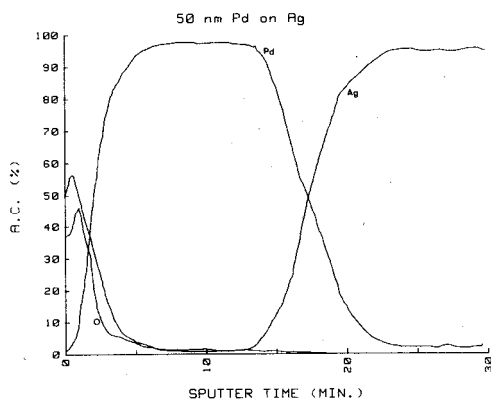
**Figure 3e.** **Auger depth profile of an exposed 50 nm Pd layer on Aq. Some Ag diffused through the thin Pd layer is found on the surface.**

The essential difference in surface scans between the palladium coated interconnectors is the presence of silver on the surface of the 50 nm palladium coating, which is not found on the 500 nm palladium coating. The thickness of this layer, containing both Pd and A9 is measured as 30 nm After further profiling a pure Pd layer is encountered and no contamination is found at the Pd/Ag interface. Comparing the profile of an exposed part of the interconnector with an unexposed one (under adhesive tape) revealed a slightly thicker Pd layer in the latter case (figs. 3e, 3f). Assuming again as in the gold case, that this is the original thickness, then the exposed Pd layer has decreased 6 nm

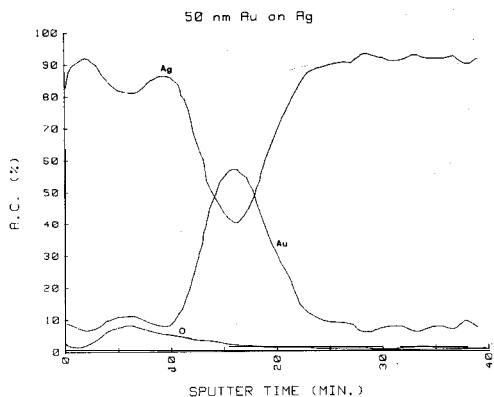
The contaminants found on the gold coated samples are mainly silver, which has apparently diffused through the gold onto the free surface, with low levels of S, O, C and Si. The thickness of the silver layer found on the gold coating depends on the thickness of the underlying gold layer. Values of 20 nm and 100 nm are measured respectively for the 500 and 50 nm gold coatings. A depth profile taken from the gold surface underneath the adhesive tape shows also diffusion of silver through the gold coating, although to a lesser extent than with the exposed surface (fig. 3b, 3c). Assuming the gold layer under the adhesive tape has still its original thickness, then the gold layer in the exposed zones has decreased 26 nm in thickness.

Figure 36. **Auger depth profile of an exposed 50 nm Au on Ag surface. A layer of approx. 1000 A off Ag is found on top of the Au surface.**

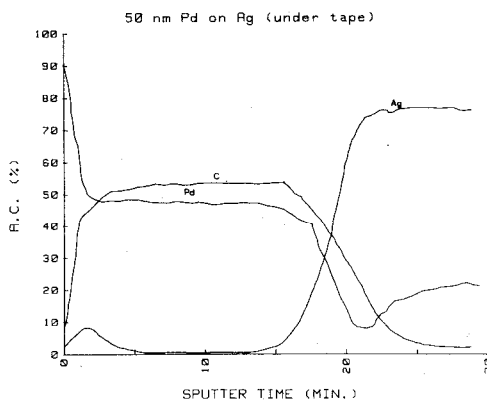
Figure 3f. **Auger depth profile of an unexposed region of 50 nm Pd layer on Ag (same interconnector as in Fiq. 2e).**

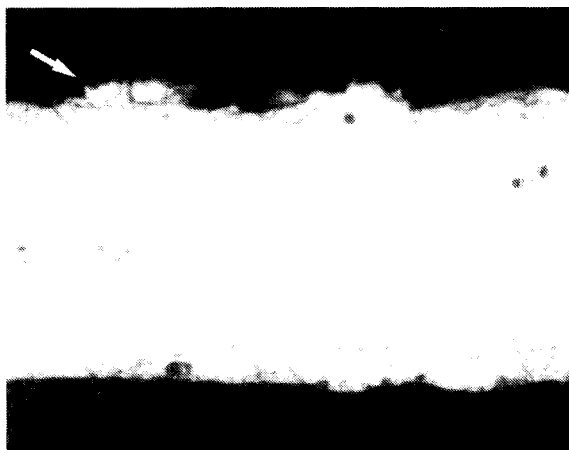
these interconnectors. To measure this decrease crosssections through the masked of regions and the exposed regions were measured. Bare silver samples tested perpendicular to the velocity vector (sample 1) with an original thickness of 34 μm have decrease 3 um reaching a thickness of 31 μm after atomic oxygen exposure. As already showed with the Auger profiling, samples tested under 45⁰ to the velocity vector are attacked to a greater depth. This is also confirmed by the microscopic investigations where sample 2 exhibit a thickness decrease from 34 μm to 29.5 μm (fig. 4a).

Figure 4a.   Cross section through an exposed region of a silver interconnector. (45⁰ to the velocity vector). The thickness is 29.5 μm (original 34 μm). Magn. X 1500

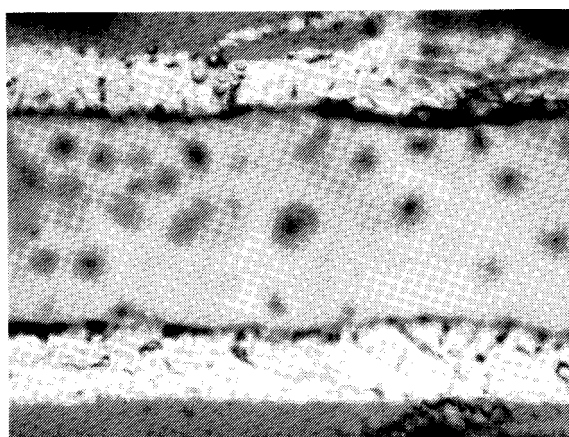
Figure 4b.   Cross section through a silver coated molybdenum interconnector, showing atomic oxygen attack of the silver. No molybdenum is exposed yet.

Microscopical results of the silver pla-
ted molybdenum gives a decrease in
thickness comparable to the bare silver
specimens, which is not supprising since
the thickness of the silver plating on
the molybdenum is 5 pm (fig. 4b).
