ATOMIC OXYGEN EFFECTS ON HST-SA1 METALS

A. de Rooij

European Space Research and Technology Centre (ESTEC)
Noordwijk
The Netherlands

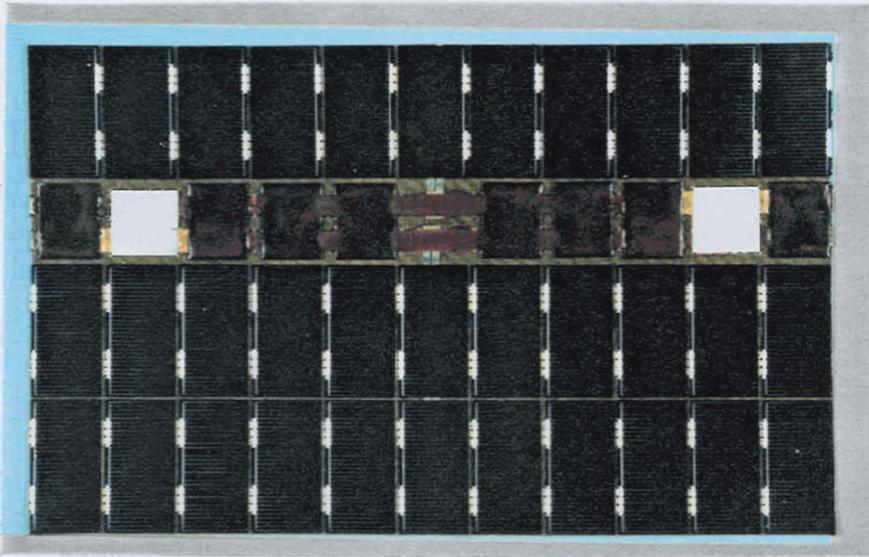
The exposed area of the interconnector is usually only the stress relief loop, the main part of the material is either under the cell towards to p-contact or under the coverglass towards the n-contact. Although this area is quite small it is the most vulnerable region of the interconnect. Also of the tapping bars the small stress relief loops are the most vulnerable visible part, but for this connector also large flat part are exposed as can be seen in figure 1.

The gold coating on the diode connectors is examined for defects and diffusion of silver through this gold coating. The connector is comprised of a gold coating of 3.5 μm on a silver thickness of 20 μm . The location of this interconnector can be seen in figure 1.

Figure 1. *Large sample cut from SPA D showing all three types of interconnectors. The bright connectors between the solar cells are the well known Ag/Mo interconnectors. The tapping bars are located in the middle of this sample perpendicular to the standard interconnectors. The two flat parts can be seen near the top at the position of the RTV coated stiffeners. The gold coated silver interconnectors can be seen at the position of the two diodes.*
Magn. X0.43

On HST-SA1 two different surface morphologies of the RTV were seen as it displayed in figure 1. Darkened (almost brown) coloured RTV was found on the glass fibre stiffeners and lightly red coloured RTV was found on the silver busbars and meander bars. In some cases the silver meander bar was under the glass fibre and a gradual change in colour was observed.
